MODEL
2011-2016MY
Optima Hybrid
(TF HEV)

NUMBER
PS515 (Rev 2, 02/28/2019)

SUBJECT: DTC P1B25/P1B77 – 125 AMP HV FUSE INSPECTION

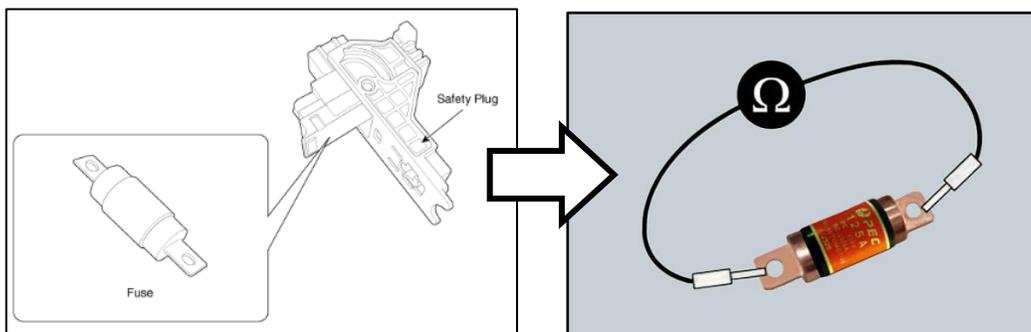
Measure the resistance while tapping on the fuse (less than $<1\Omega$ resistance).

Specification: 1Ω or less (68°F)

If the measured resistance is not within specification, or the P1B25 DTC is intermittent, replace the 125 Amp HV Battery Fuse with the newer 150 Amp HV battery fuse (part #375F2 4R150).
